Look for a satisfactory explanation for the iPhone 6 Plus bending error

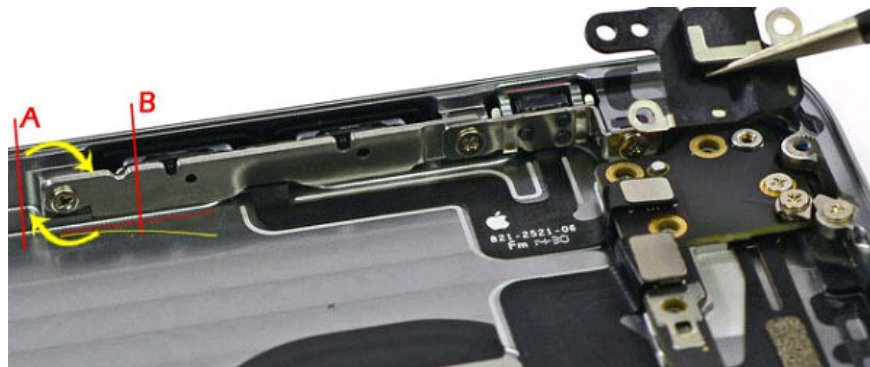
A user with the nickname *alleras4* passed the *Imgur.com* website to speculate that the bending problem of the iPhone 6 Plus is not only derived from the ruggedness of the aluminum casing. There is no way to verify that claim, but one interesting thing is that this explanation corresponds to the dissection of iFixit.com. Accordingly, the deformation of iPhone 6 Plus comes from the reinforcement on the inside of the phone, right behind the volume control button. There, the metal reinforcement bar has a screwed head, making the iPhone body more pressure-sensitive.

"This means that the added metal bar is not capable of absorbing the impact force too close to the screw, because it does not have any other vital points to grip, so it is rotated in the direction of the force. *alleras4 - alleras4* said. Here is an explanation of iFixit:

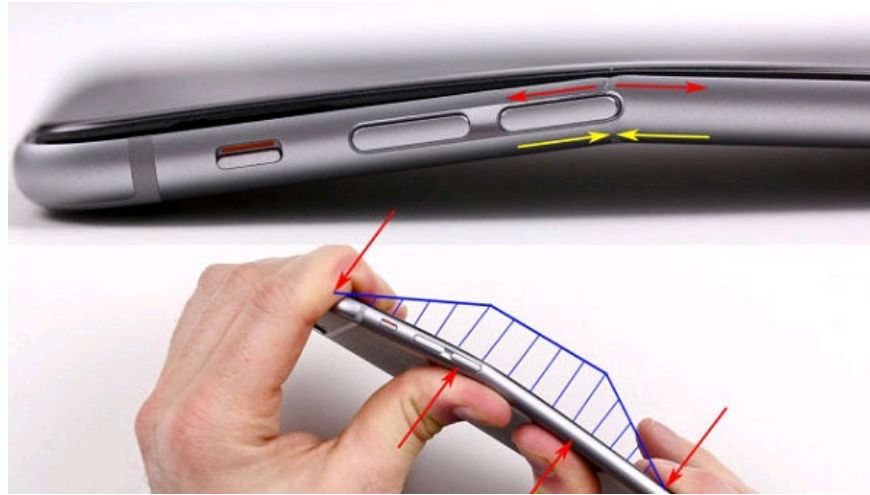
Alleras4 said this was the highest pressure point, and illustrated this with a diagram (below). It describes the places where force (*in this case the user's hand force / compressive force is sitting on*) impacting on iPhone 6 Plus and the results appear at the most impacted point (*the point is easily deformed or bent*).

In other words, this issue has nothing to do with the finger or weight of the iPhone owner. The reason is that the iPhone 6 Plus impacted at the right point, from the right angle, where the internal hardware of the Apple-designed phone was faulty.

Industrial designer Don Lehman, after seeing this explanation, said: " *This is perfectly reasonable. Look at where the distortion begins on the aluminum cover - it is right next to a very strong connection. sure* ". He also commented that this will only happen with a very small portion of users, and it does not seem that the design of the iPhone 6 Plus will be changed. " *If we dissect an iPhone 6 Plus in the future, will it be the same now? I think yes ."*
