# Vision Pro owners report a strange crack in the front glass

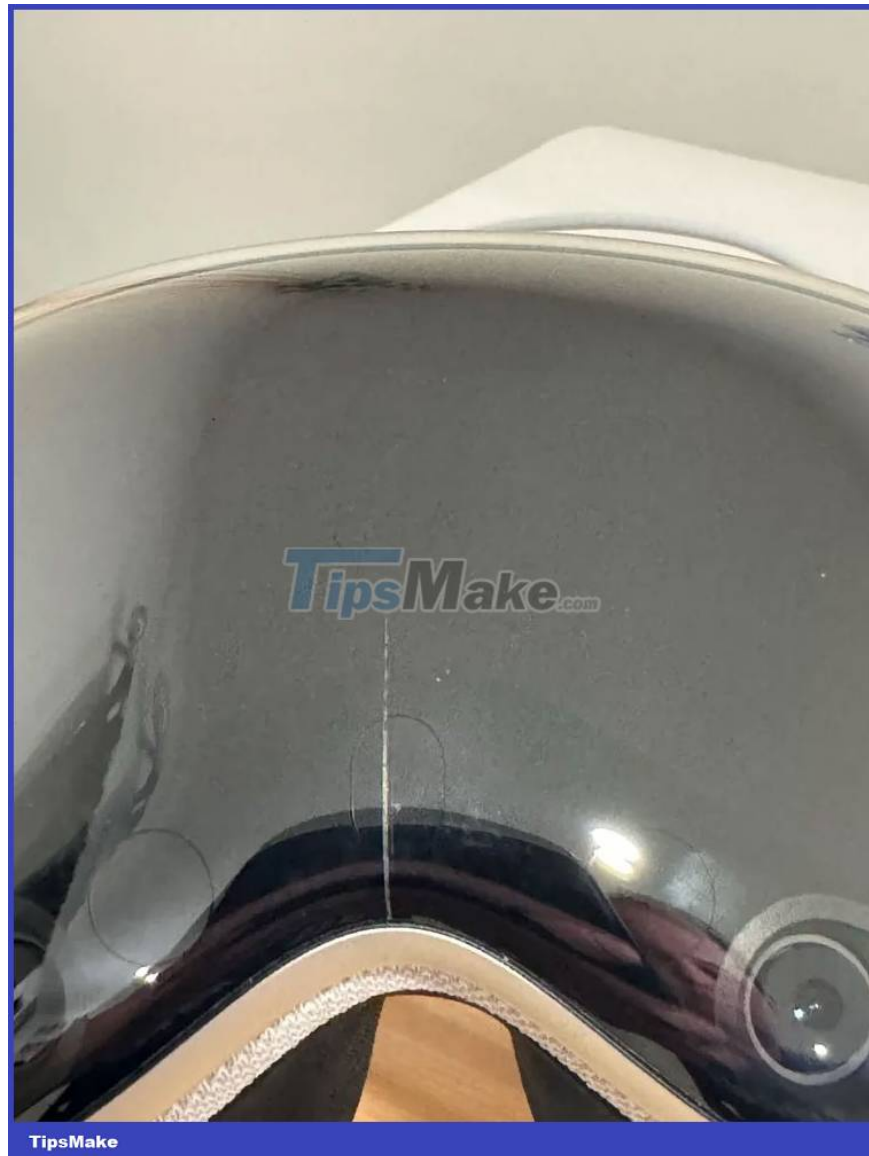
What is curious is that all of the uploaded photos seem to show vertical hairline cracks in the same area above the bridge of the nose. All of the affected Redditors said that they did not do anything that could cause the cracks, such as dropping or improperly storing the device. Reddit user @dornbirn said that he polished the front glass, opened the soft cover, put it in the box and saw the crack the next morning. Most of the other affected Redditors also said that they kept their Vision Pro in a case or opened the soft cover.

There is some speculation that this could be a heating issue when charging the Vision Pro in the case or when the lid is closed. Others say it could be a manufacturing issue with the glass or simply a design flaw that puts too much pressure on that particular area.

It's also unclear whether the hairline crack is just a cosmetic issue as it appears to be on a sensor but doesn't obstruct any cameras. However, Vision Pro repairs are expensive. With Apple Care - which costs \$500 for the Vision Pro - the cost is \$299 if the glass is damaged. Without Apple Care, repair costs will be up to \$799. @ContributionFar8997 wrote that they visited the Apple Store and were told they would have to pay to fix the problem.
