What does the hole in the back cover of some Intel CPUs do?

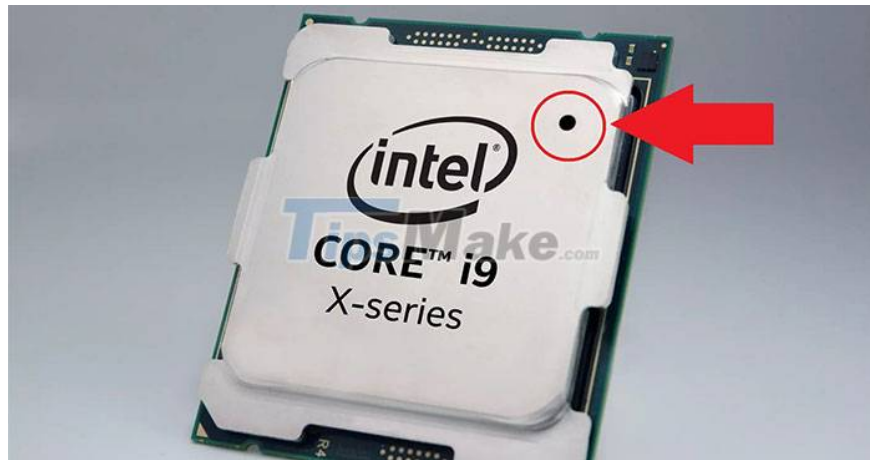
Some Intel CPUs have a hole in the corner, such as the Core i9 X series. So, what does this hole do, if the thermal paste falls in it? The following article will help you to come up with the answer.

The hole in the back cover of some of these CPUs is what Intel calls a vent hole - the 'vent' that dissipates heat and aligns.

At the Intel factory, the back cover (IHS) is glued to the circuit part of the CPU with epoxy glue. Then, this hole will be the place for the air to escape. Without it, the air will be trapped inside the CPU causing the air pressure to increase, causing the glue line to deform, causing the glue to be uneven.

However, old thermal paste often falls into this hole and is very difficult to remove. According to Intel's confirmation, it will be okay for normal non-conductive thermal paste to fall into that hole.

However, with a liquid metal glue capable of conducting electricity, it is a different story. Some people think that there are a few small components under the CPU cover, so if the liquid metal glue sticks to it, it will cause short and damage. So, if you intend to remove the CPU cover and apply liquid metal thermal paste, you should be careful with CPUs with holes. To ensure safety, it is best to seek the help of a professional repairman to avoid possible unfortunate incidents.
